TRENCHLESSWORKS

ISSUE 195 2022

LINING A GEOMETRICALLY COMPLEX MESS INVOLVING A LEAKING GAS MAIN

By George Ragula, RagulaTech, Morris Plains, New Jersey, USA

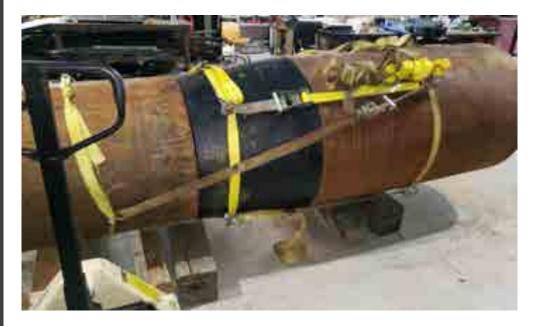
Minimal liner wrinkling confirmed.

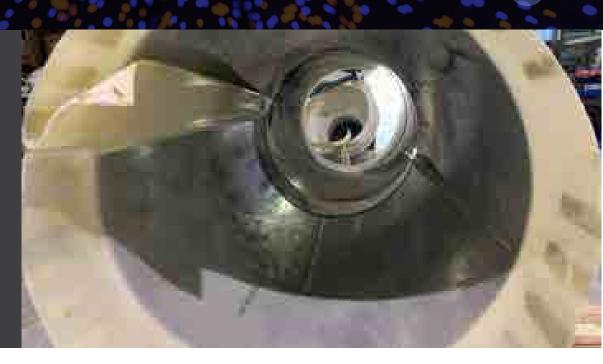
Field installation of guide pipe with reducer.

The solution was to add a short section of 36 in (910 mm) diameter pipe with a second 30x36 in reducer to the end of the 30 in (760 mm) diameter CI pipe to ensure proper alignment of the liner and stability before entering the 30 in (760 mm) diameter pipe. Since this had never been performed before, testing was performed to confirm the anticipated results. The results verified proper liner alignment could be achieved and steady state conditions reached to minimise wrinkling in the installation without negatively impacting the integrity of the liner.

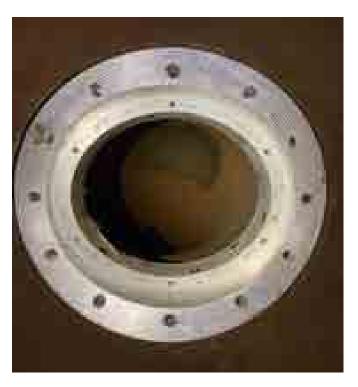
Plug with 2 components assembled.

The solution was a specially designed and fabricated restraint plug consisting of three major components for ease of assembly into the 36 in (910 mm) diameter pipe using confined space entry protocols. This plug was designed to act as a bearing surface for the liner inversion and planned 25 psig pressure test. Prior to project start, it was tested to ensure ease of installation and reliability of operation.

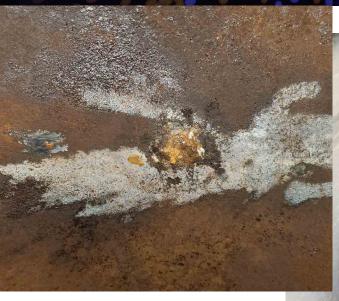
4. Leaking 30x36 in (760x910 mm) Reducer – The steel reducer was corroded and there was concern the air pressure from either the liner inversion, pressure test or 15 psig operating pressure over time could lead to failure of the fitting, and potentially leading ultimately to liner failure.

Corroded 30x36 in (760x910 mm) diameter steel reducer.

The solution involved spraying an approximate ¼ in (6 mm) layer of high strength epoxy using spin casting techniques to reinforce the leaking fitting, while adding rigidity and strength to the fitting.

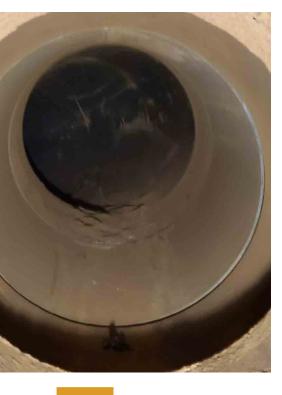
5. Inoperable 30 in (760 mm) Valve – Ideally, this gate valve would have been cut-out to accommodate lining operations, but the maze of utilities surrounding it prevented that. Instead, it had to be abandoned in-place. The fitting contained a 6 in (150 mm) wide well for the gate operator to close through, leaving a weak point for liner installation.

30 in (760 mm) diameter gate valve well.

The solution would normally be to use a carbon fibre structural reinforcement sleeve (SRS) to bridge the well gap to provide adequate bearing surface for the liner, but since the design was employing the use of epoxies for other aspects of the work and their manpower/equipment was in the pipe anyway, bridging the gate well with epoxy was less time consuming and more efficient.

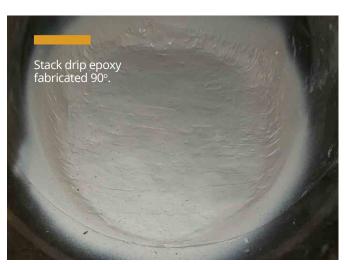
3. Stack Drip Transformation – The stack drip consisted of a 36x36 in (910x910 mm) tee at a depth of over 15 ft (4.5 m) with a capped vertical leg looking down. Such fittings were always installed at the lowest point of a segment of pipe and used to periodically pump fluids out of the main that may have collected. The geometry was extremely complex and normally would have been replaced with two 90° bends, but it was in an area containing monitoring wells from an abandoned gas station making it extremely time consuming and costly to replace. From prior experience, the project team knew that a liner could never be successfully inverted through such a complicated geometry.

Stack drip aggregate.

Familiarity with epoxies used in various applications led to a solution whereby the concept of fabricating a 90o bend out of the tee was devised, since the leg looking down was no longer needed. The process envisioned was to leave sandblast grit material after the main cleaning process which is an integral process of lining to properly prepare the pipe for maximum liner adhesion to a 6 in (150 mm) level below the invert of the tee, backfill it with aggregate, and then hand apply high temperature high strength epoxy to smooth out the epoxy to form a 90° bend out of the tee.
