OVERCOMING CHALLENGES KEY TO WORLD RECORD 36-INCH CIPL GAS MAIN RENEWAL

World Record Diameter Gas Main Relined in South Orange, NJ

By: George Ragula, Public Service Electric & Gas

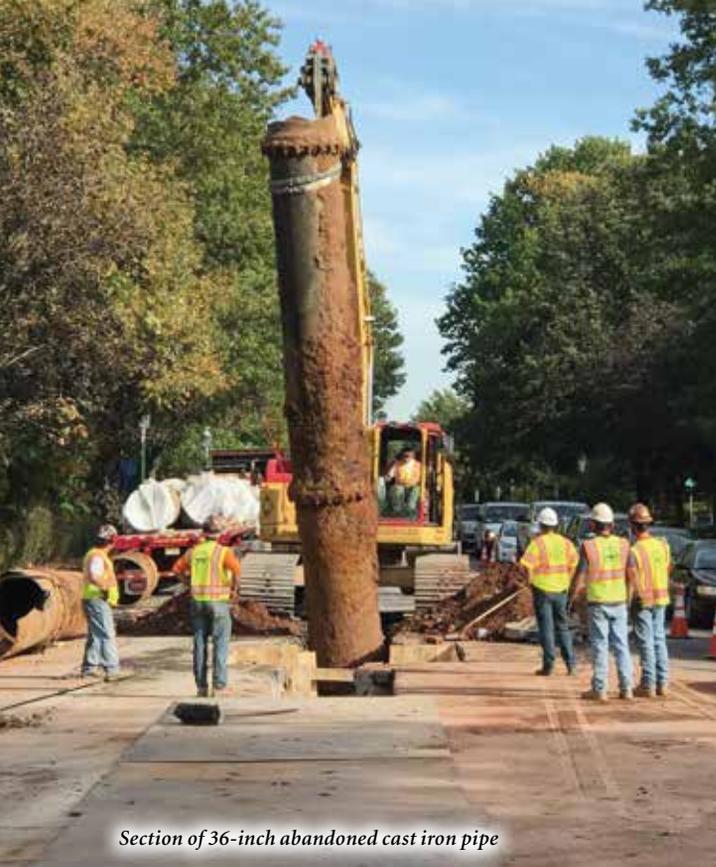
Section of 36-inch abandoned cast iron pipe

This large diameter feeder main reline was one of the most demanding projects of my 40-year career. Running under this section of South Orange Ave. was a 2,000 LF stretch of 36-inch cast iron gas main pipe originally installed in the fifties. With increasing deterioration over the years a lot of short term sporadic emergency work had been done on this section of cast iron pipe, however a long term permanent solution for this critical feeder main had not yet been formulated. There were now

a total of 15 known joint leaks pinpointed along this section so it was critical immediate action be taken to implement a comprehensive long term solution.

Ultimately, the best and most effective long term solution we found required a Cured-In-Place-Liner (CIPL) renewal of this 2,000 LF section of 36-inch cast iron gas main – a new world record as the largest diameter CIPL project ever done on a gas main! This challenging undertaking required innovation,

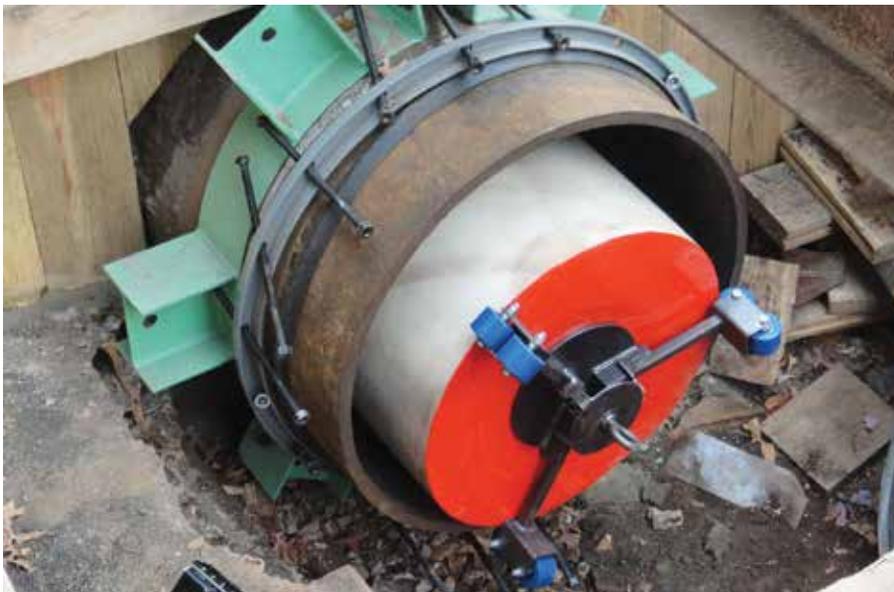
Custom pig fabricated to remove stranded grit

first. However post-cleaning inspection revealed there was still roughly a 150 foot

length of stranded grit material remaining in the pipe after the vacuum removal process was complete. Two more vacuum sources were added the next day to bring the total to seven vacuum units, along with a special fitting to increase suction. Even after an entire extra day was spent using seven vac sources, there were still piles of grit left behind in the pipe. A conventional pig didn't work to push the grit out either.

Time to innovate. We fabricated a custom pig with rollers and a tethered hold back. The rollers centered the pig into the pipe reducing the area into a small annular space. This drastically increased the suction velocity in the areas between the pipe's interior surface and pig. With vacuum source at one end we would slowly pull the pig back towards the other end against the airflow, moving it over the areas where grit had accumulated. We used CCTV to monitor the pig's position and confirm grit removal. It took us another day using this innovative process to successfully remove all the stranded grit.
