UV CIPP RENEWS STORMWATER DRAIN AFTER OTHERS FAIL

Project: 36-inch Stormwater Drain Renewal
Location: Middlesex County, New Jersey
Length: 70 feet

Client: Industrial Manufacturer
Contractor: Progressive Pipeline Management (PPM)
Method: UV Cured-in-Place-Pipe

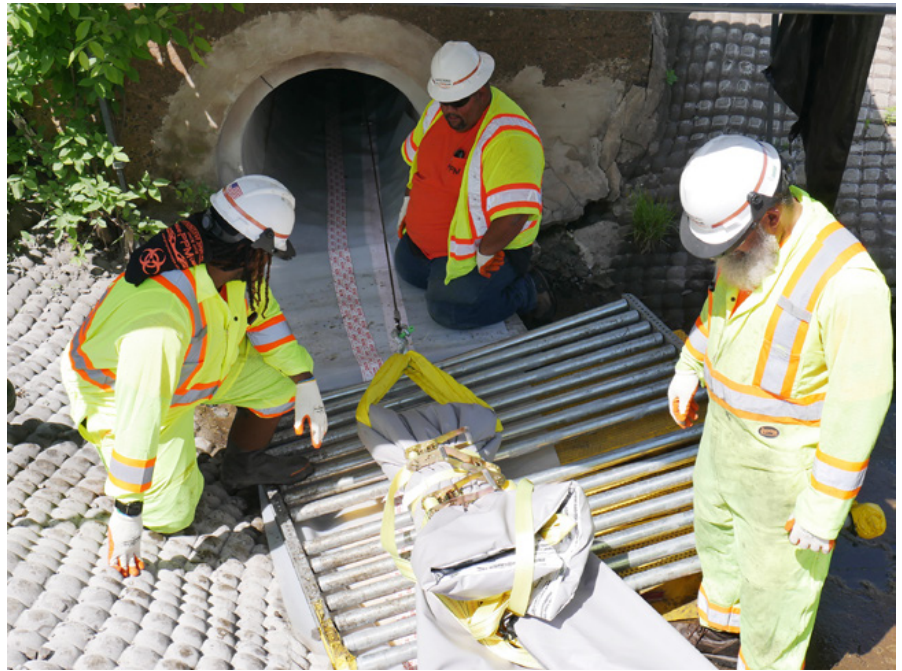
The UV CIPP liner was dragged into place inside the drainpipe using rollers and a winch cable

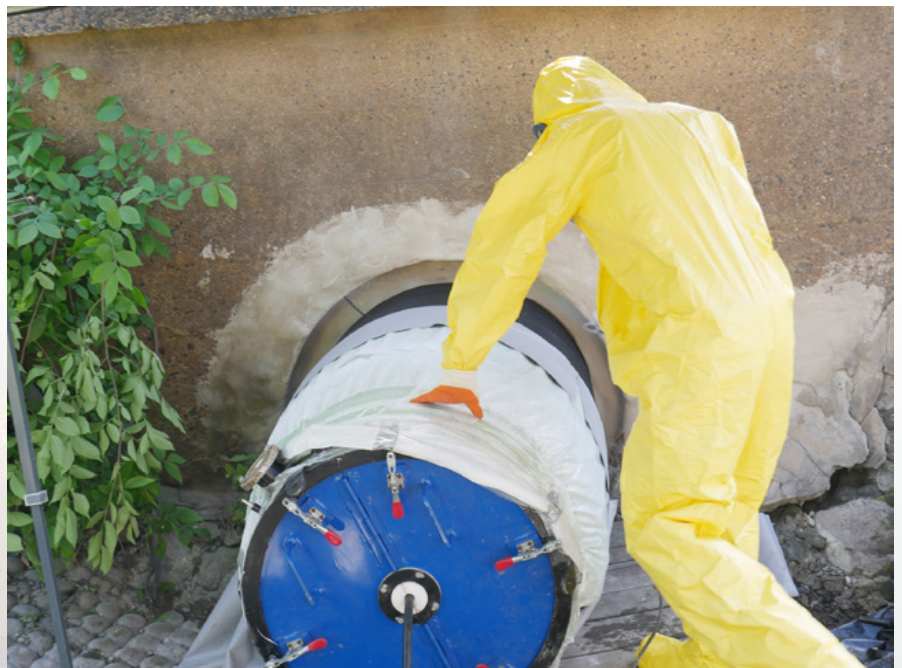
The end gate (blue) had a port on the side for pressurizing with compressed air to inflate the liner. The cable attached was used to pull the liner into place

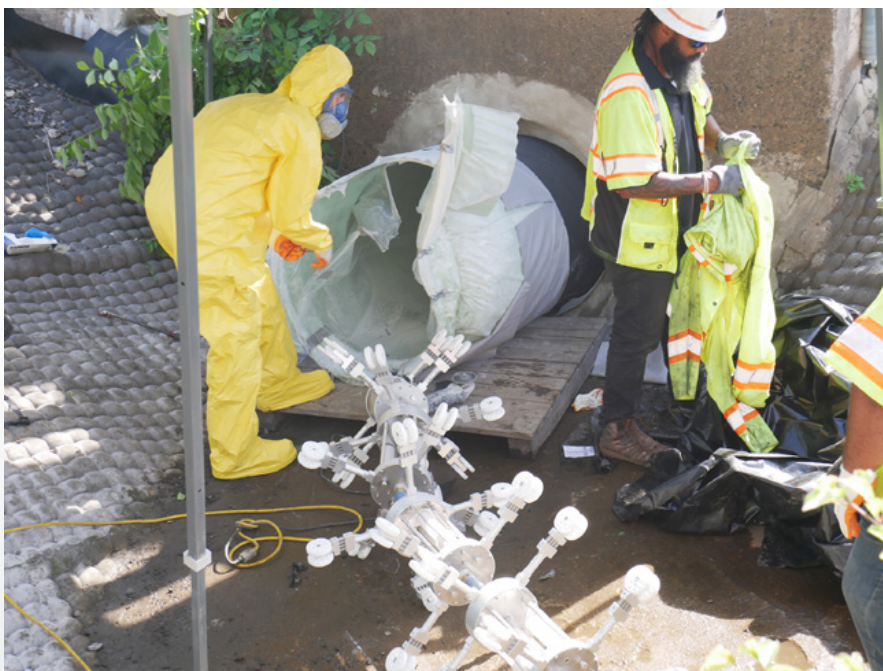
The light chain was pushed and pulled in a timed sequence to cure the inflated liner to the host pipe

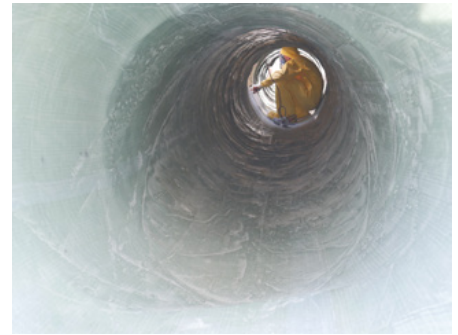
Using confined space entry, the final cured liner was entered to re-instate the center manhole lateral connection

After the CIPP was installed and cured, the crew had to open a manhole inside a channel to reinstate a lateral that took on stormwater flow. The lateral flowed into the stormwater drain system. This was done in collaboration with the municipality, as the manhole was owned by the township. A right-angle grinder was used to cut out the material.
