NATURAL GAS

JESSUP ROAD, NEW JERSEY

NEW JERSEY UTILITY

# PIPELINE WALL CONDITION ASSESSMENT BROADBAND ELECTROMAGNETIC (BEM) 135 FEET / 12" MAIN UNDER RAILROAD CROSSING

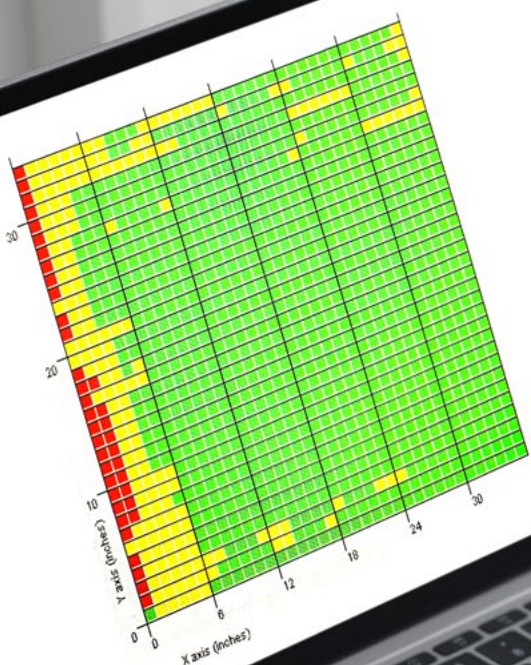
BEM heatmap with colors indicating wall thickness

The acquired data was downloaded to a laptop via a data cable. Graphs depicted as heat maps with color contours indicate the level of wall thickness. If the pipe wall thickness is between 90 to 100 percent, meaning a loss of 0 - 10 percent, it shows as green. If the pipe wall thickness is between 70 to 89 percent, a loss of 11 to 30 percent, it shows yellow, which is an indication of some metal loss at that particular sensor location. If the pipe wall thickness is less than 70 percent of the original thickness, it would be red, indicating an area of major concern.

The results of the project (in the image above) provided sufficient evidence and data to show the railroad company owner that the section of pipe running underneath the railroad was well within the standards required to proceed with Starline® Cured-in-Place-Lining technology. With the evidence to present to the railroad owner, the utility was cleared to remediate the main and avoid a costly and disruptive pipeline replacement.
