CROSS BORE INSPECTION TECHNOLOGIES:

Lights, Camera, Action

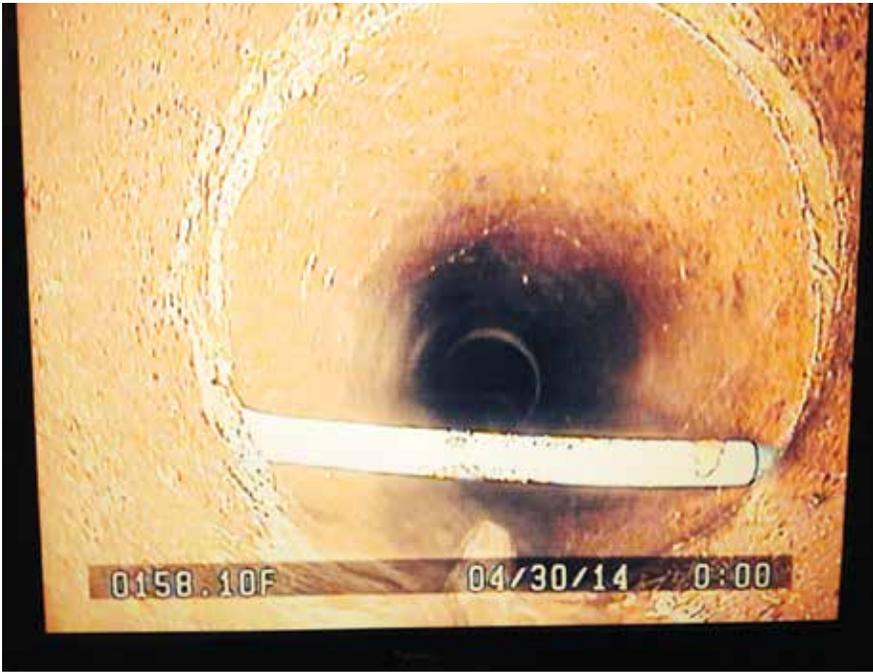
Screen shot of an actual cross bore

A typical natural gas HDPE plastic pipe that has been directionally drilled is narrow and bright yellow. When you see it in the lateral you know instantly. We follow protocol with immediate notification to the gas utility. It's an emergency situation and the utility sends a response team to excavate and repair within 24 hours. The homeowner is notified not to use any facilities.

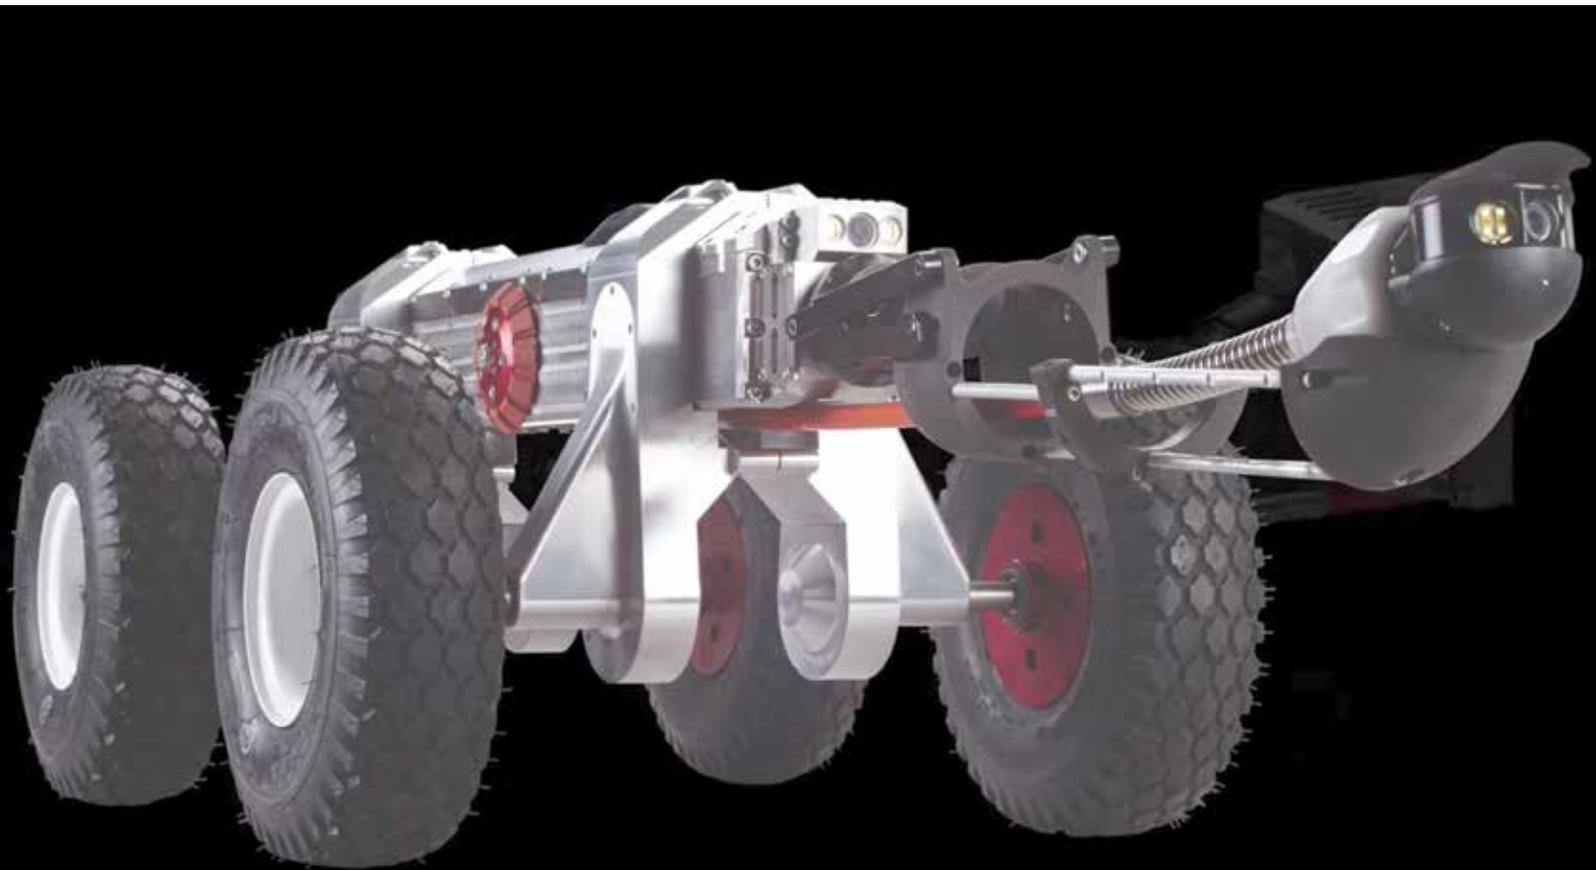
Aries camera with Lateral Evaluation Television arm

There are only a few companies making cross bore investigative cameras. PPM has partnered with Aries Industries for over a decade. The cameras have crystal-clear views with full color pan-and-tilt capability, which greatly improves the ability to traverse difficult laterals. The mainline crawler is like a small tractor that drives itself through the sewer main. The LETS arm and the lateral camera launches off the top of the main camera into the sewer lateral for distance up to 150 feet.

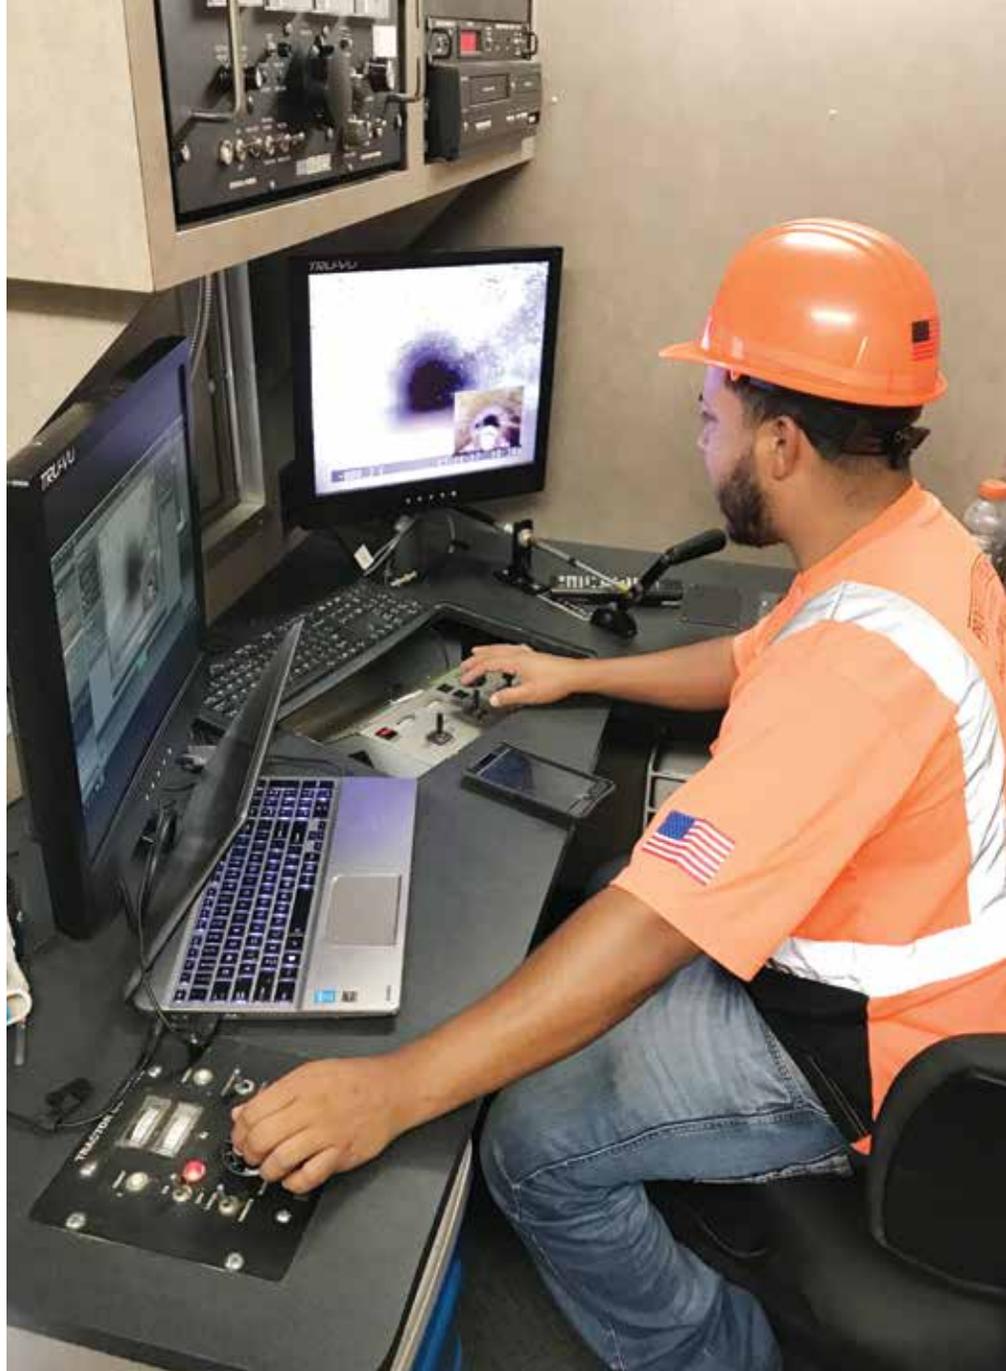
Fabian Becerra PPM Operator at the CCTV control station

The camera and rig consists of a remotely operated camera mounted on a self-propelled robotic crawler connected to a video monitor. The system is truck mounted with an operating station. The back of the truck houses the electric or hydraulic reel system and cabling that connects to the camera. The operator sits at a control station that looks like an XBOX console. Two flat screen displays show the live view of the mainline camera and the view from the lateral with the LETS camera arm.
