LOCATION
EAST ORANGE, NEW JERSEY

CLIENT
PUBLIC SERVICE ELECTRIC & GAS

PROJECT PROFILE

REPAIRING BRIDGE PIPELINE WITH CURED-IN-PLACE-LINING AVOIDS COSTLY REPLACEMENT 12" MAIN

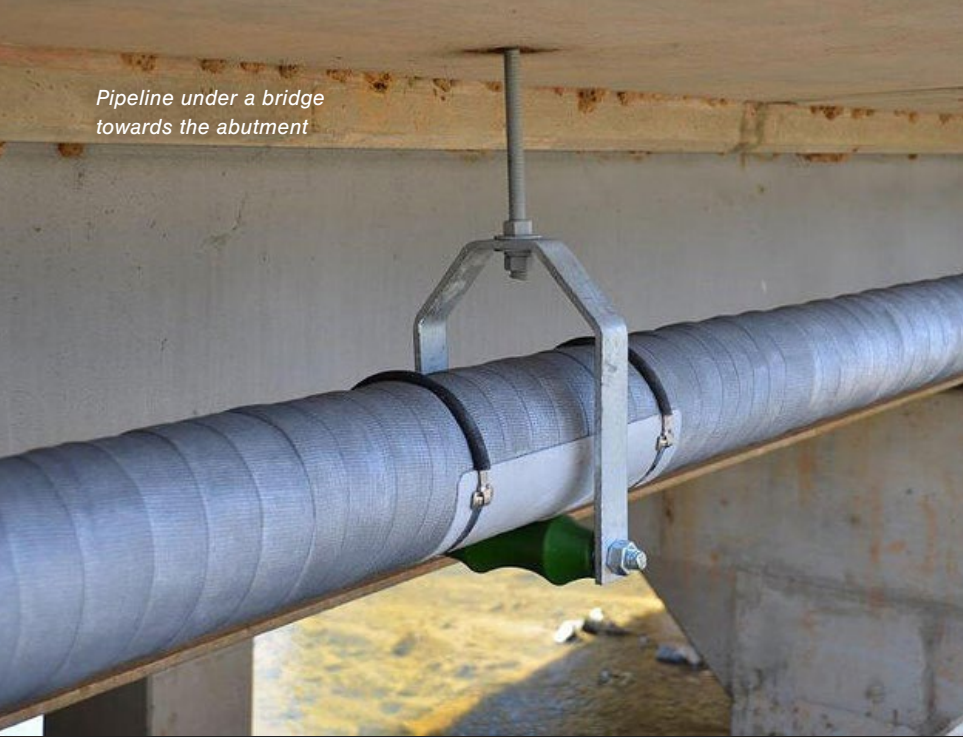
Pipeline under a bridge
towards the abutment

The PSE&G 12-inch gas main pipeline along Park Ave. in East Orange NJ, travels directly through a bridge concrete abutment wall. The segment crossing the bridge had evidence of corrosion and leakage. PSE&G looked to PPM to recondition the segment within the abutment wall without removing the pipeline or interfering with the bridge structure.

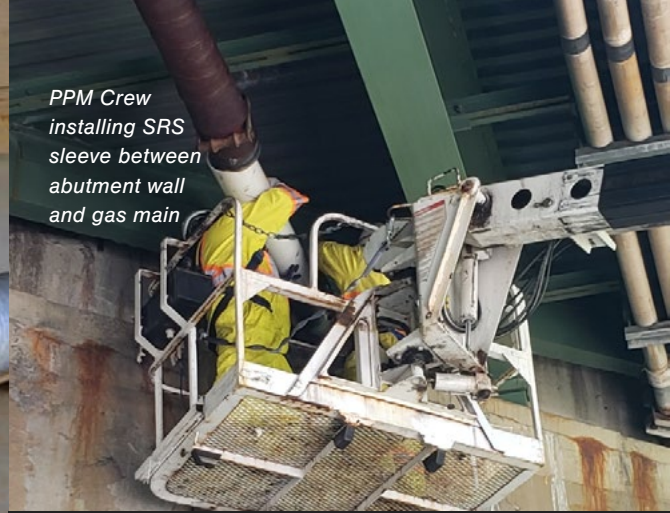
PPM Crew
installing SRS
sleeve between
abutment wall
and gas main

Prior to lining, the section where the pipe enters the abutment wall was reinforced with a structural reinforcement sleeve (SRS) made of a high strength carbon fiber laminate with a glass outer skin/coating. The sleeve was installed robotically using an inflatable bladder, inserted into the pipeline and held in place, overnight, until the adhesive which holds the sleeve cured. Laminate composite material and glass outer coating prevent corrosion where the sleeve meets the abutment wall.

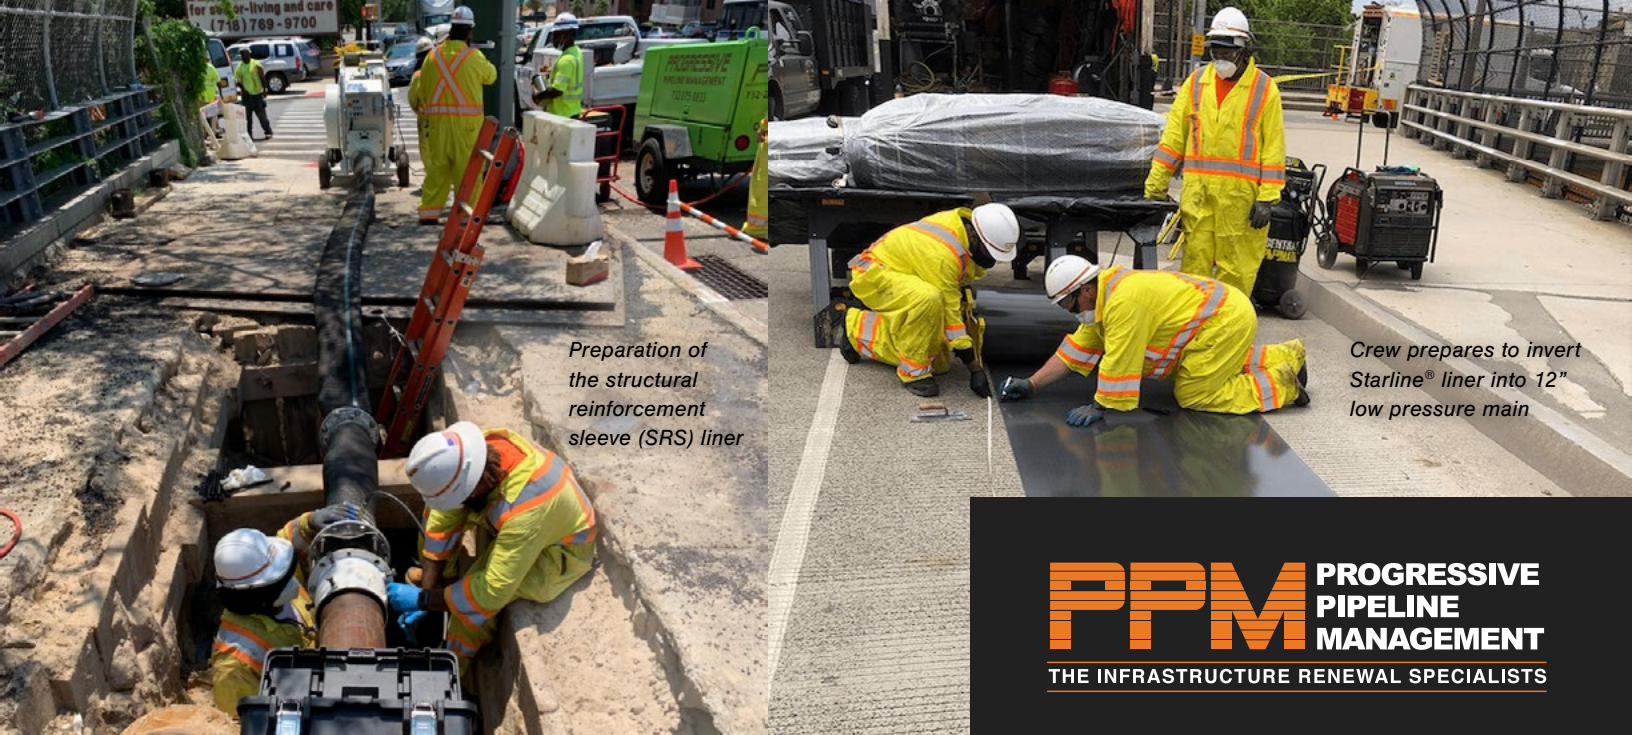
Preparation of the structural reinforcement sleeve (SRS) liner

Crew prepares to invert Starline® liner into 12" low pressure main

The carbon fiber material bonds to the interior of the pipeline, essentially becoming the host pipe for the Starline® Cured-in-Place-Lining (CIPL) installation. The pipeline internal surface was inspected with CCTV and prepared for lining using an abrasive sandblasting operation. The liner was loaded into the drum and installed into the main using air pressure.
