## 2018 Project of the Year Rehabilitation Winner: 36-in. CIPL Gas Main Rehabilitation Project 0

BY MIKE KEZDI ON OCTOBER 23, 2018

The 36-in. high-pressure, cast-iron feeder main, installed in the 1950s, was a known problem for PSE&G at the time of the renewal in fall 2017. The main had 15 known joints with active leaks, elevating concerns regarding the safety

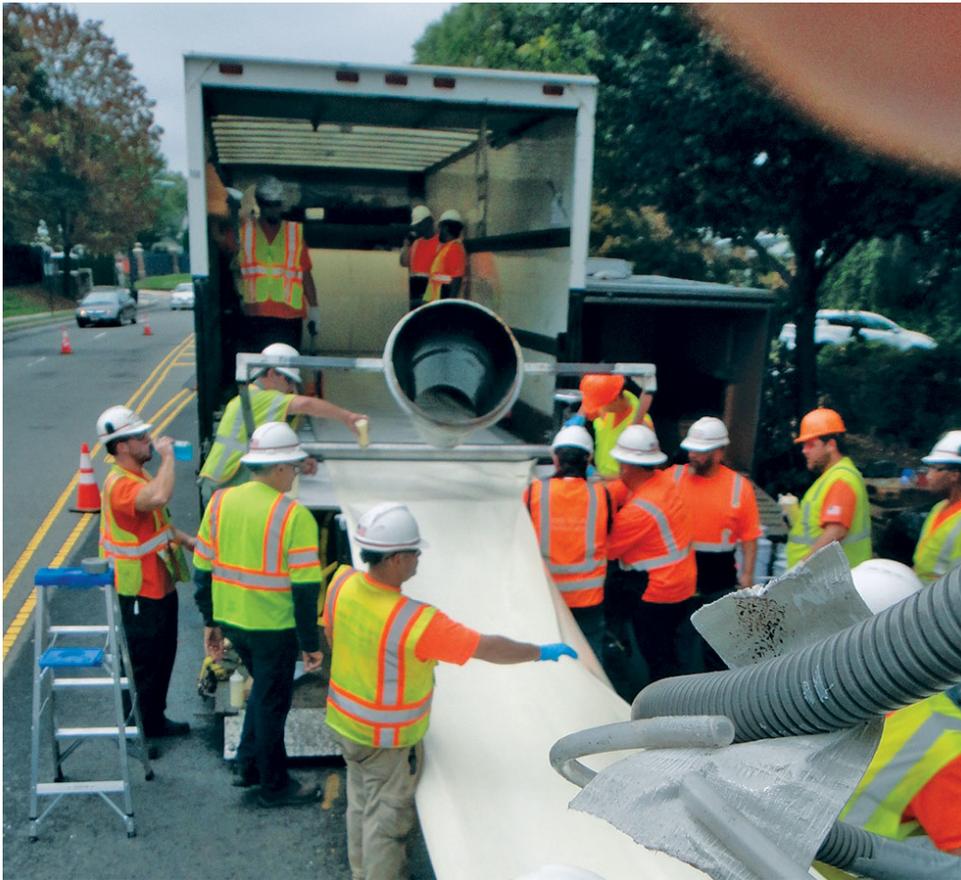
*The Starline cured-in-place liner is guided from the truck to the inversion drum. The lining took place in four segments.*

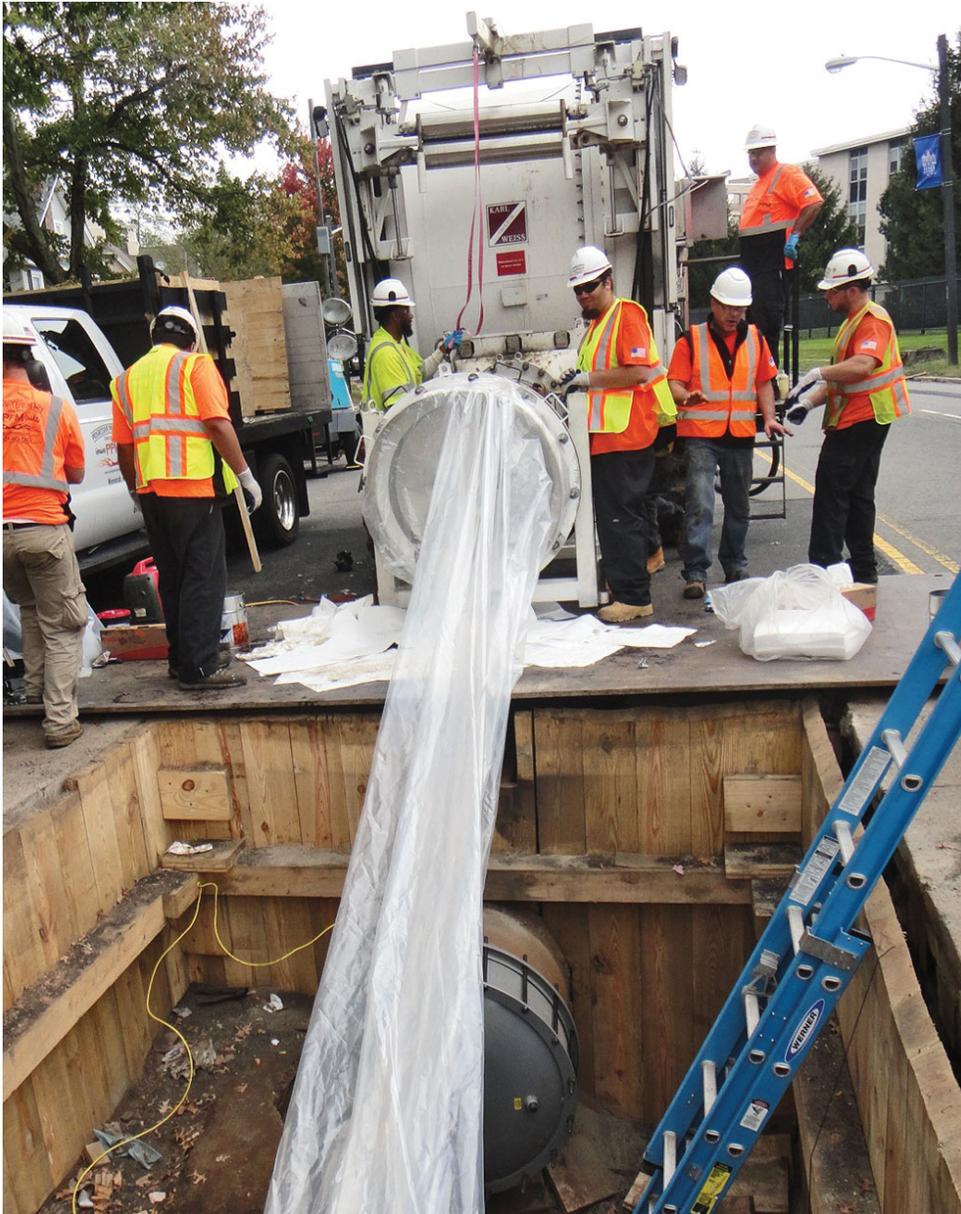
*The 36-in. CIPL liner was inverted above the lining pit and transferred to the host pipe via a transport tube. This setup led to some initial challenges for the crew, including liner chafing and liftoff.*

In its previous CIPL work, the inversion took place in the lining pit but due to the size of this liner with related equipment and the planned excavation pits, all of this had to take place above ground. This led to non-optimal entry angles for the liner into the host pipe.

After the liner was cured in three of the segments, it was discovered that there was slight liner liftoff, also known as delamination, that occurred near where the liner entered the host pipe. After the discovery, repairs were made with epoxy and specially fabricated retention bands to hold the liner in place while curing.

In segment one, and also due to the entry angles, the liner chafed and caused minor leaks due to the size of the 8-in. retention belt used to guide the liner into place. The leaks were fortunately outside of the pipe and in the remaining segments the retention belt switched to 4 in. and the lubrication was doubled resulting in no further chafing or leaks occurring.

After facing these in-field challenges, Ragula says that on future large diameter projects – more 30-in. and possibly a 42-in. is on the horizon – the team will opt for a longer excavation area for the lining pit to accommodate the larger inversion cone and transport hose from the pressure drum.

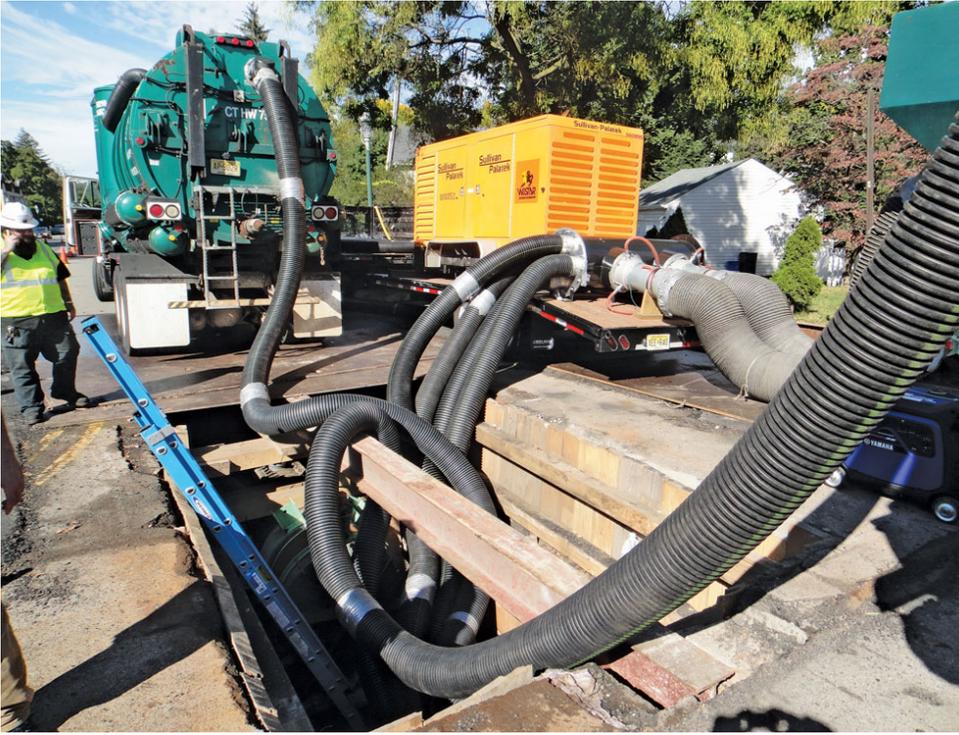
As with other CIP relining work, the host pipe needs to be as clean as possible for the liner to adhere. PPM crews sandblasted the pipeline to an almost virgin white pipe to meet a NACE 2 visual standard. To remove the grit, crews used several vacuum trucks combined with a Venturi system to optimize air flow. Even with this modified system, in segment two they found a long section of grit remaining. They tried several options to no avail.

*PSE&G and Progressive Pipeline Management devised a series of vacuum trucks to create a Venturi system to remove the silt and grit from the pipe cleaning process in advance of the relining.*

With input from its partners at Karl Weiss, PPM created a special pig that would be pulled through the segment, increasing the airflow velocity by narrowing the internal diameter of the pipe. This allowed crews to remove the grit with the vacuum equipment they had on the project. While this process took place, the team moved ahead with lining segments three and four.
